What would you do if you discovered underground water leaks were costing you \$8,000 per month?

## The Find: Large Underground Water Leak

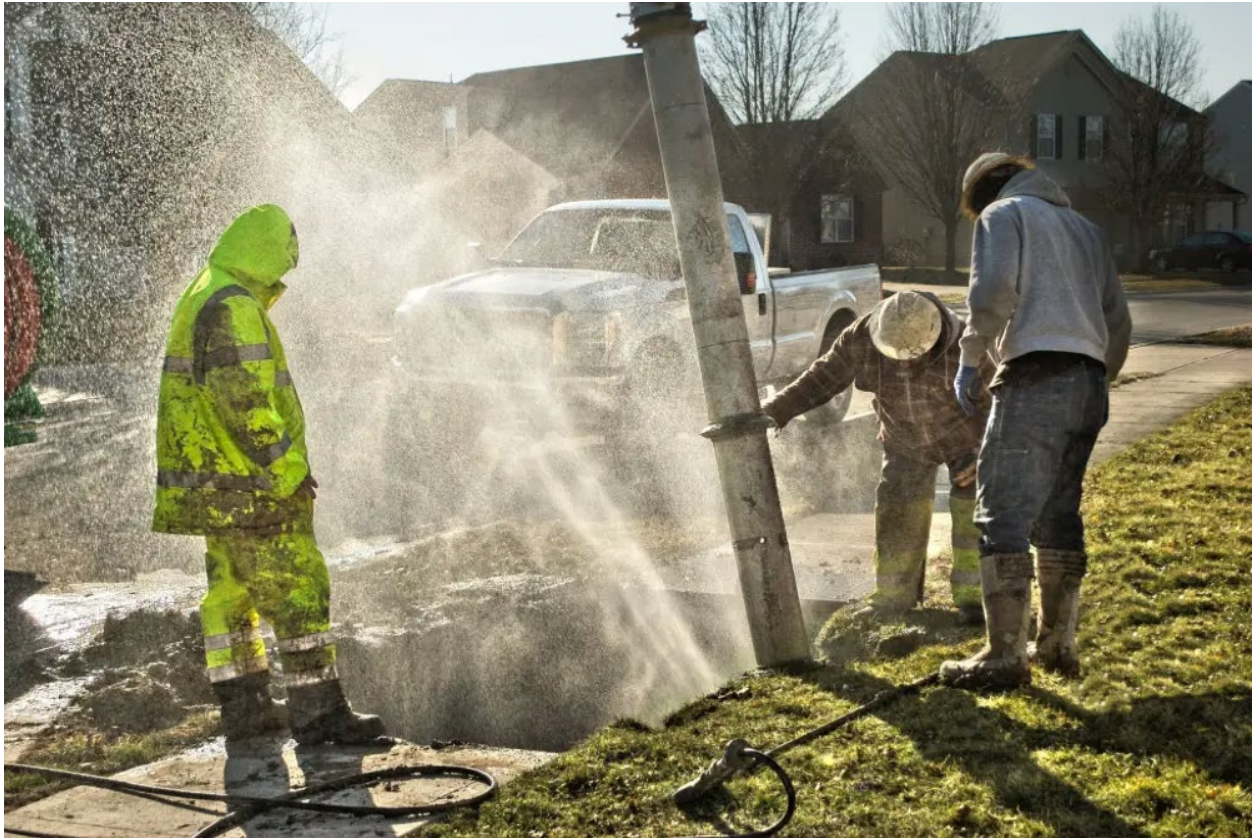
**Image Description:** Underground water leaks can cost time, money, and risk the safety of you and your team if not proactively addressed.

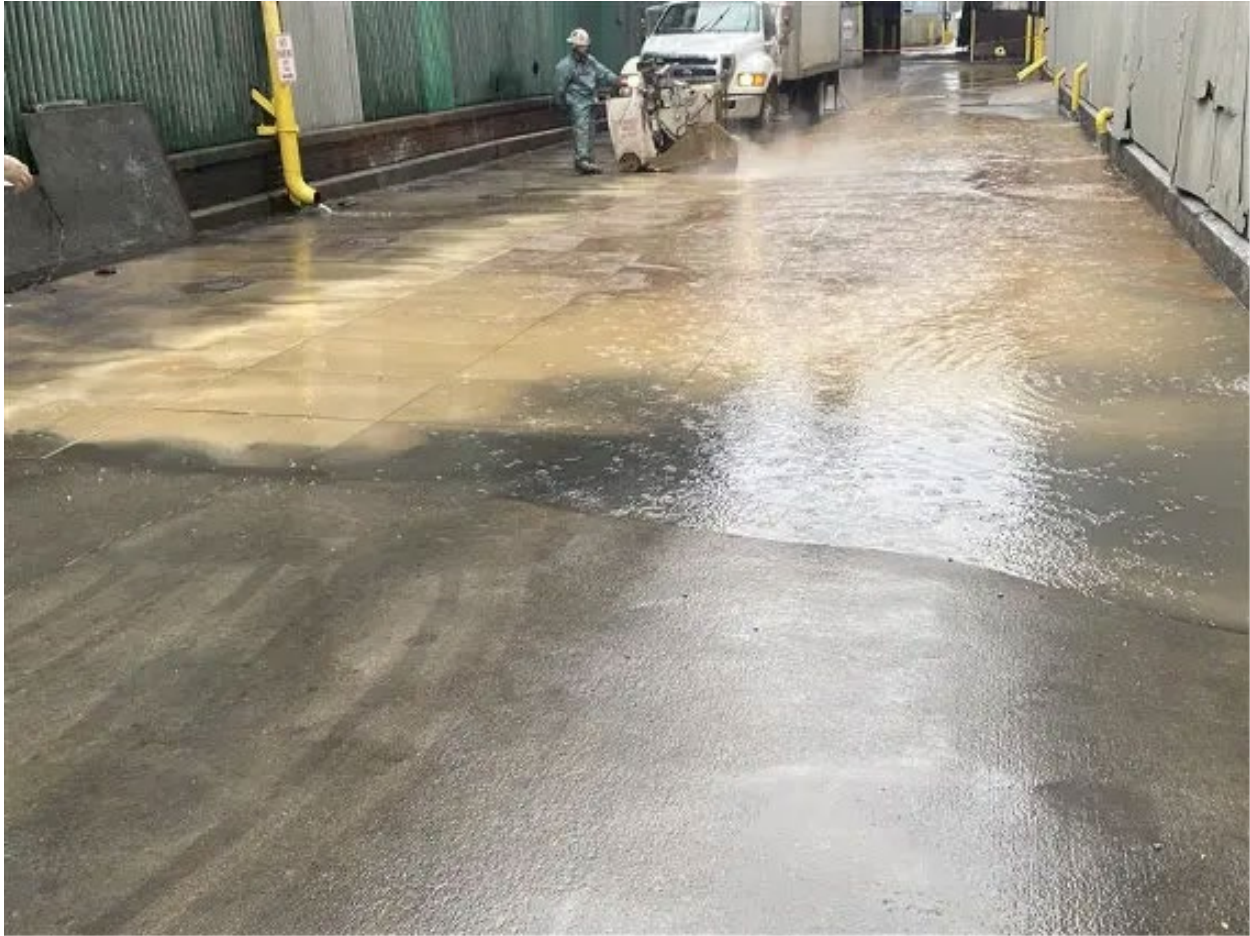
Farther along the domestic water line, away from the initial investigation's focal point, Blackburn uncovered a defect within the system—a **significant leak hemorrhaging over 700,000 gallons of water** in the few months prior to it being discovered. His proactive approach and skillful application of the industry's best technology and his trained ear allowed him to differentiate between leaks and other ambient noises. This culminated in tangible financial savings for Mersen. Through the discovery, the Mersen plant was able to stem the outflow and prevent an astounding \$96,000 dollars per year in non-revenue water loss.

**Image Description:** Flooded job site due to massive underground water leak at plant

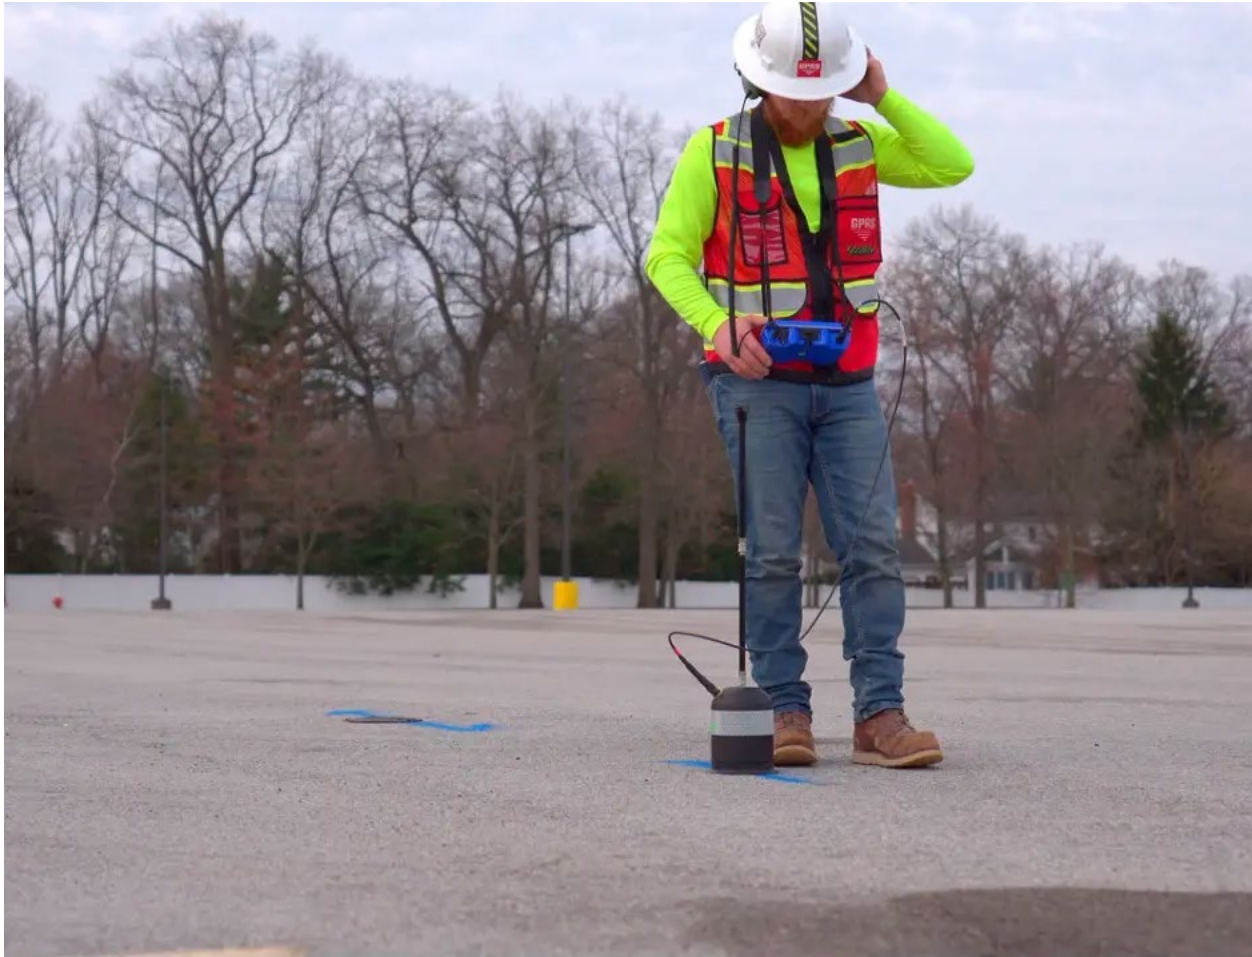
Impressed by this discovery and the estimated \$8,000 dollars- worth of monthly savings as a result of Blackburn's diligence and investigation, the plant's Facility Engineer requested that the entire property have a full-scale site leak survey to unearth any remaining hidden leaks. The ductile iron water pipes provided a cooperative medium for the leak detection equipment, including the elephant foot by FCS, created for the very purpose of blocking additional noise to listen and pinpoint the exact locations of a leak.

**Image Description:** GPRS Project Manager pinpoints exact location of subsurface water leak with FCS’s Elephant Foot.

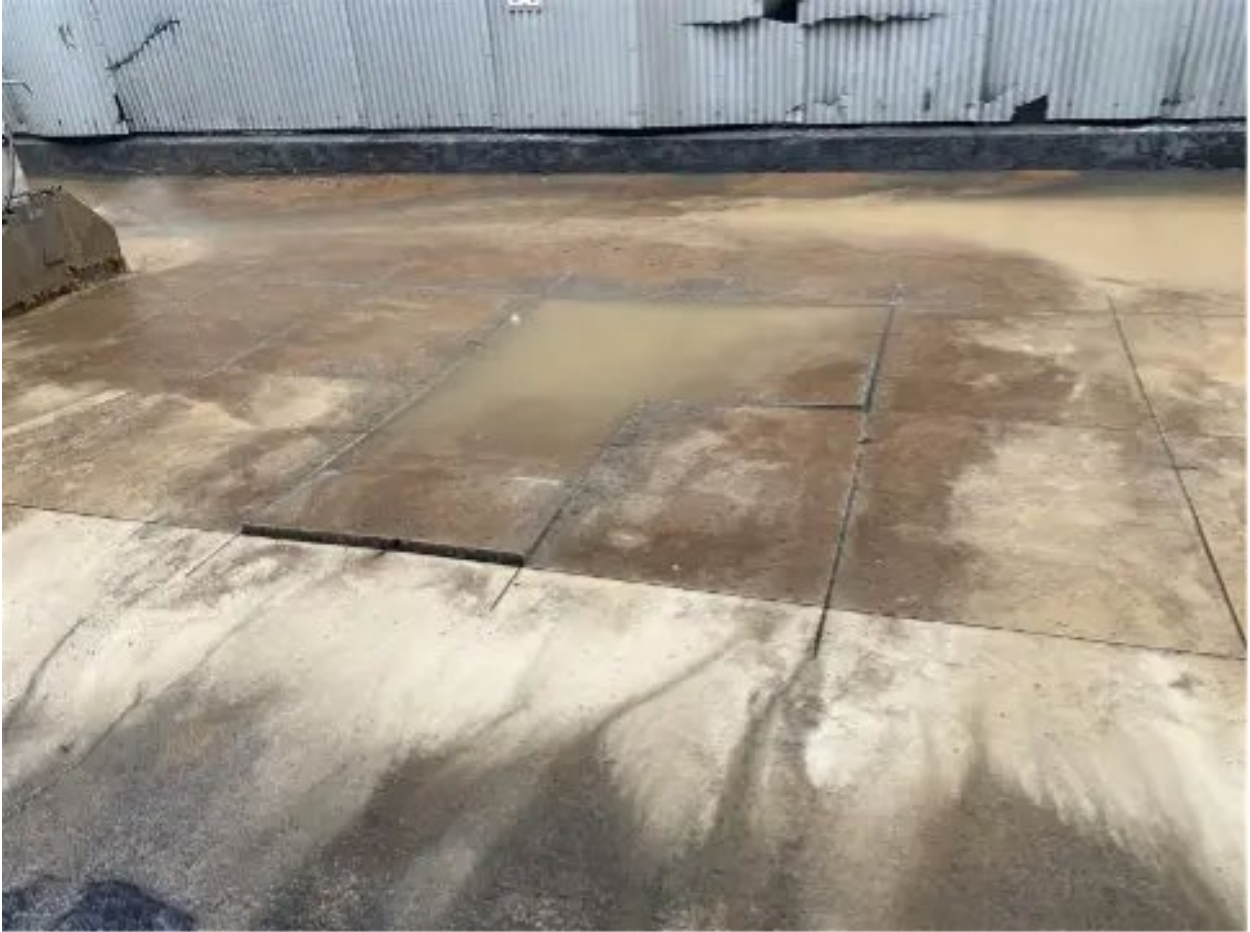
The subsequent finds from the remainder of the site’s water lines were staggering. **Blackburn identified five additional leaks, including a large break in an 8-inch fire line system that was gushing out 10,000 gallons out water per day.**

The team at Mersen had to shut off the fire line to repair the leak on the 80-year-old system because water was spewing up from the ground when the surface was disturbed for repairs. Evidence of the water’s unrelenting force, washing out the foundations it flowed beneath, are shown in the image below—a danger that would have remain undetected if not for the vigilant eyes and ears of Blackburn and his equipment.

**Image Description:** Concrete slab sinks into the ground once saw cutting occurs due to an 8" ductile iron water line with a full circular break.

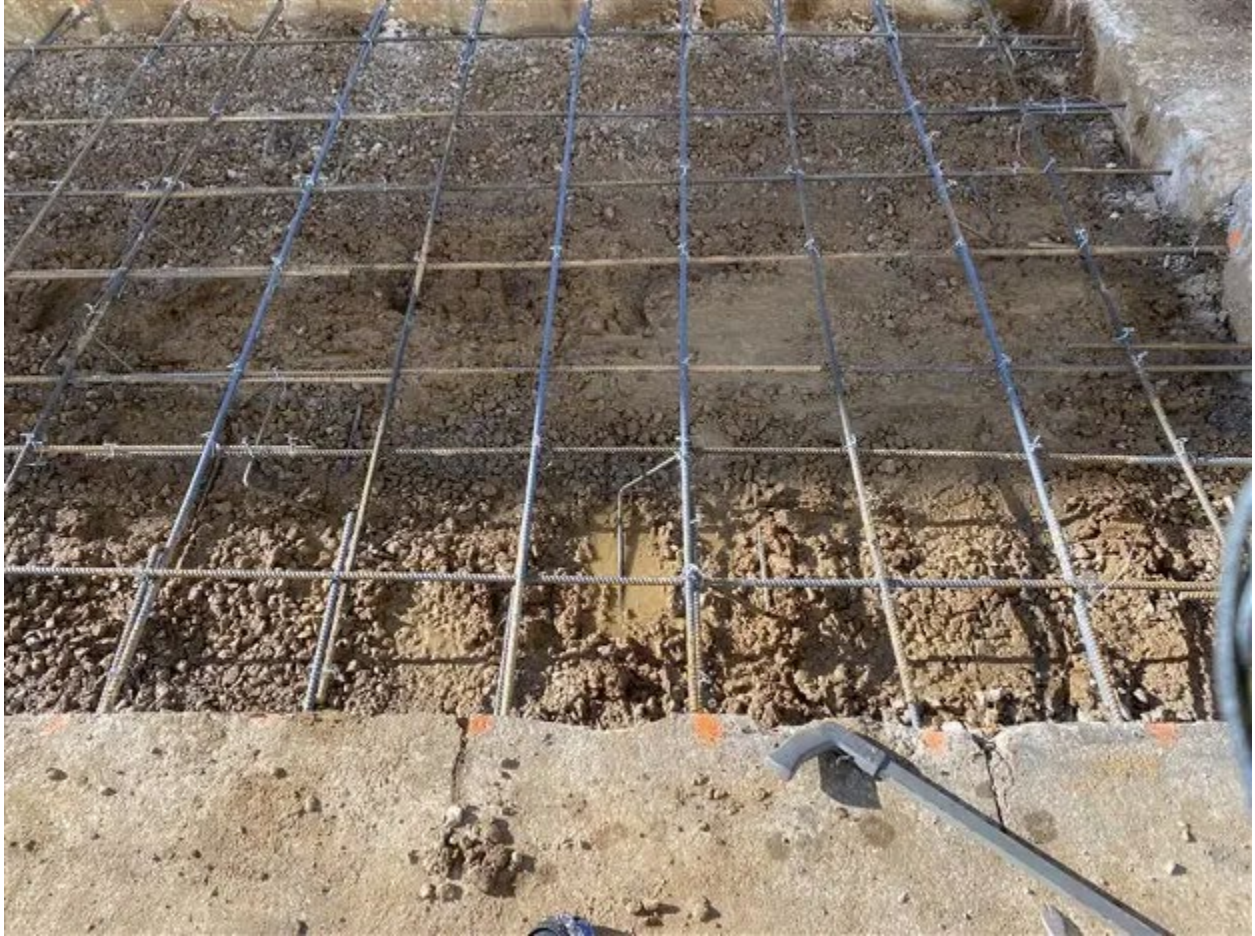
Capitalizing on silence during a recommended full plant shutdown, Blackburn, with his acoustic leak devices and well-trained ear, investigated for additional leaks on the ductile iron system. Post-repair, GPRS' SiteMap® platform stored the newly updated water map as-builts, providing Mersen with an invaluable, updated digital map, a stark contrast from the out of date 22-year-old chart they had been using.

Once the leaks had been located and accurately marked, repair work began. From saw cutting of the concrete and excavation of dirt to the repair of the leaking line and repaving of the asphalt, Blackburn's extra effort from day one when paired with our equipment on the job resulted in a safer site and a massively reduced water bill.

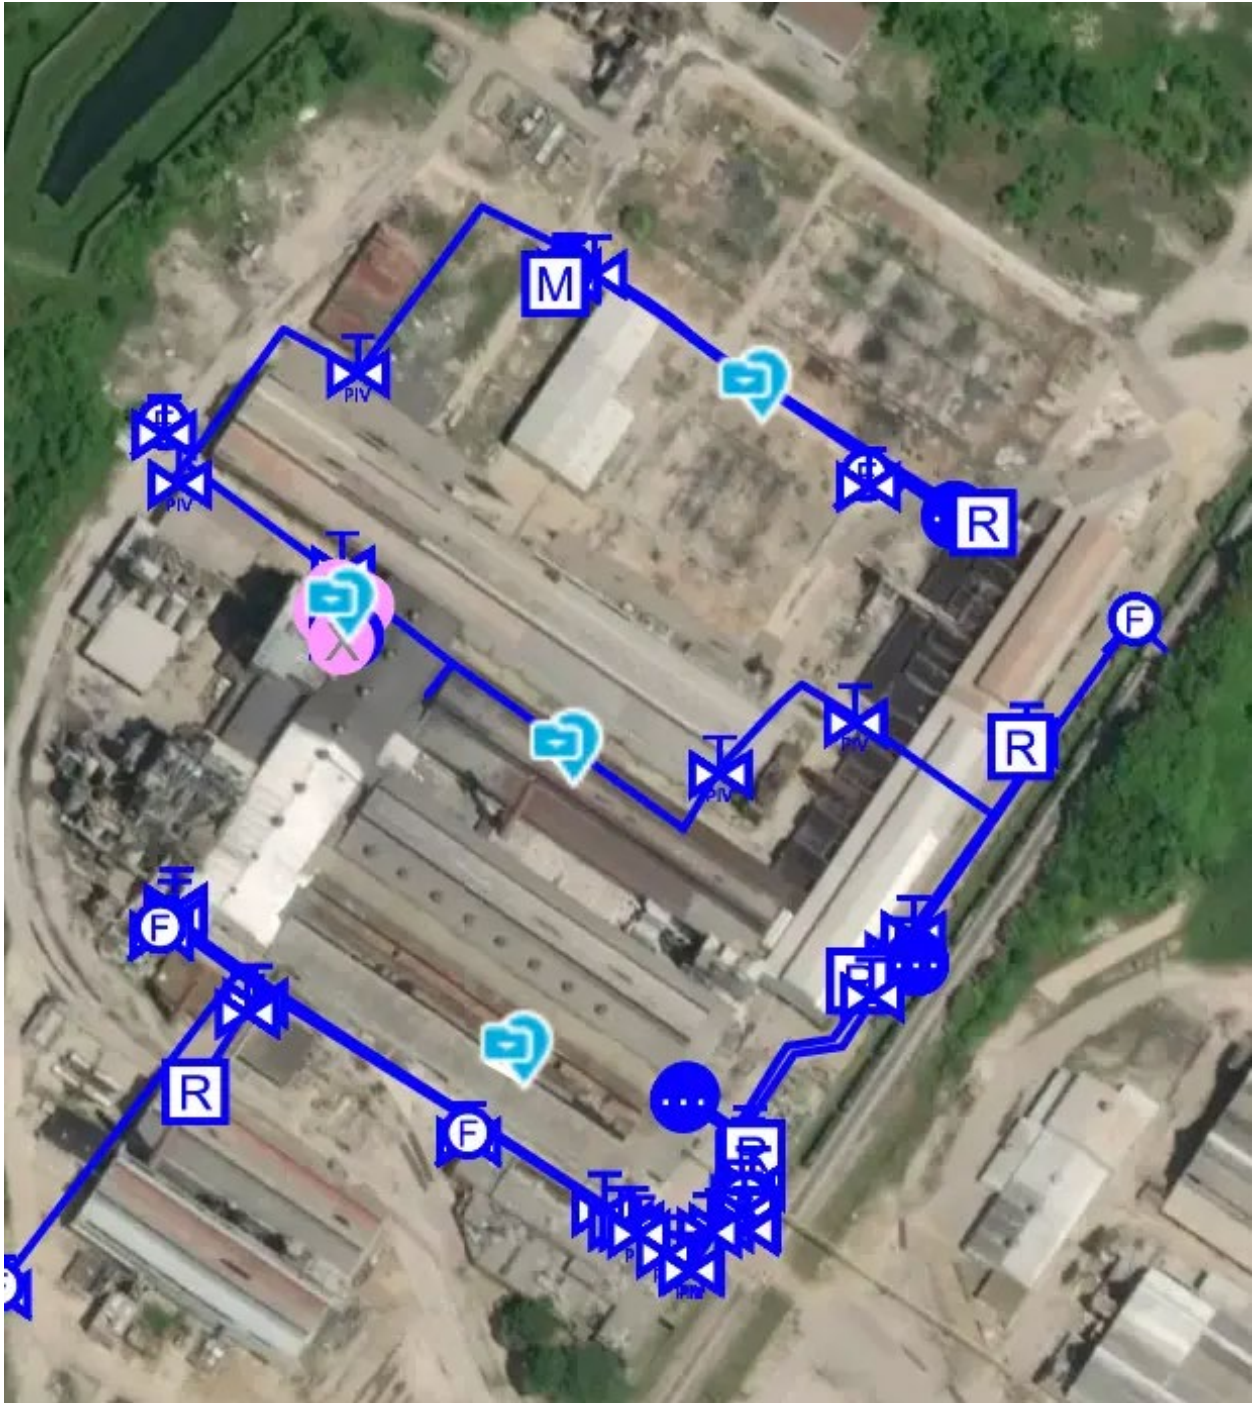
**Image Description:** Water Utility Mapping Software, SiteMap® displays all accurate water utility as built documentation for Mersen plant.

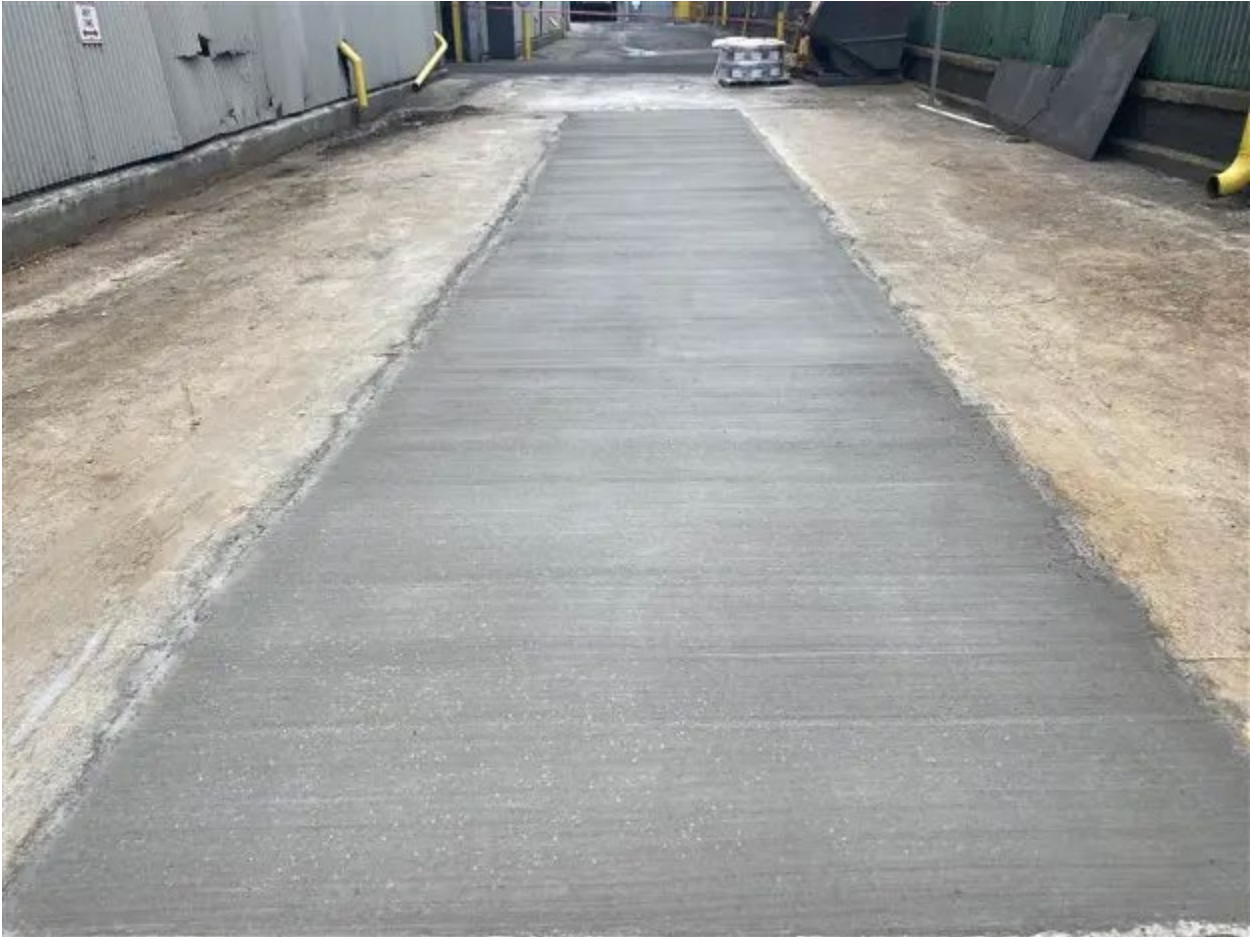
**Image Description:** Concrete slab repairs after fixing underground water line.
